NATIONAL TRANSPORTATION SAFETY BOARD

MATERIALS LABORATORY FACTUAL REPORT

Report No. 10-122

Place : Waxahachie, Texas
Date : January 23, 2010
Vehicle : Tecnam P2002
NTSB No. : CEN10FA107
Investigator : Tom Latson

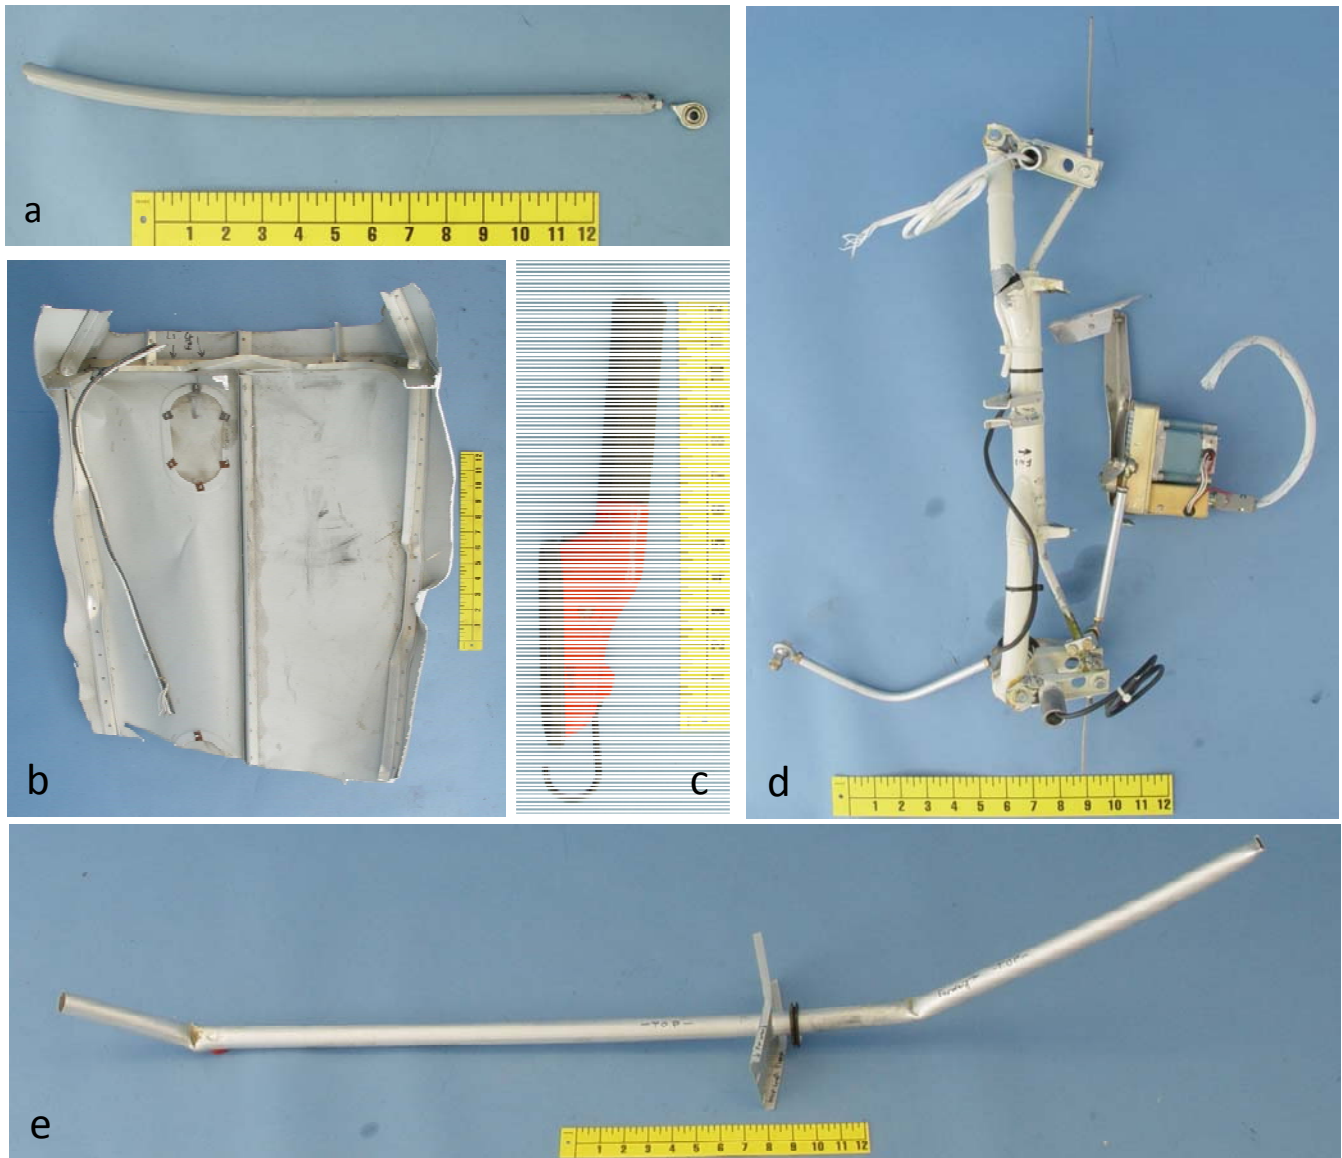
Figure 2 Parts submitted for this examination: a) forward stabilator control tube with fractured forward rod end; b) bottom piece of fuselage tail section including stabilator control tube pass through plate mounting braces; c) mechanic's work light; d) control mixing unit; e) aft stabilator control tube with pass-through plate.

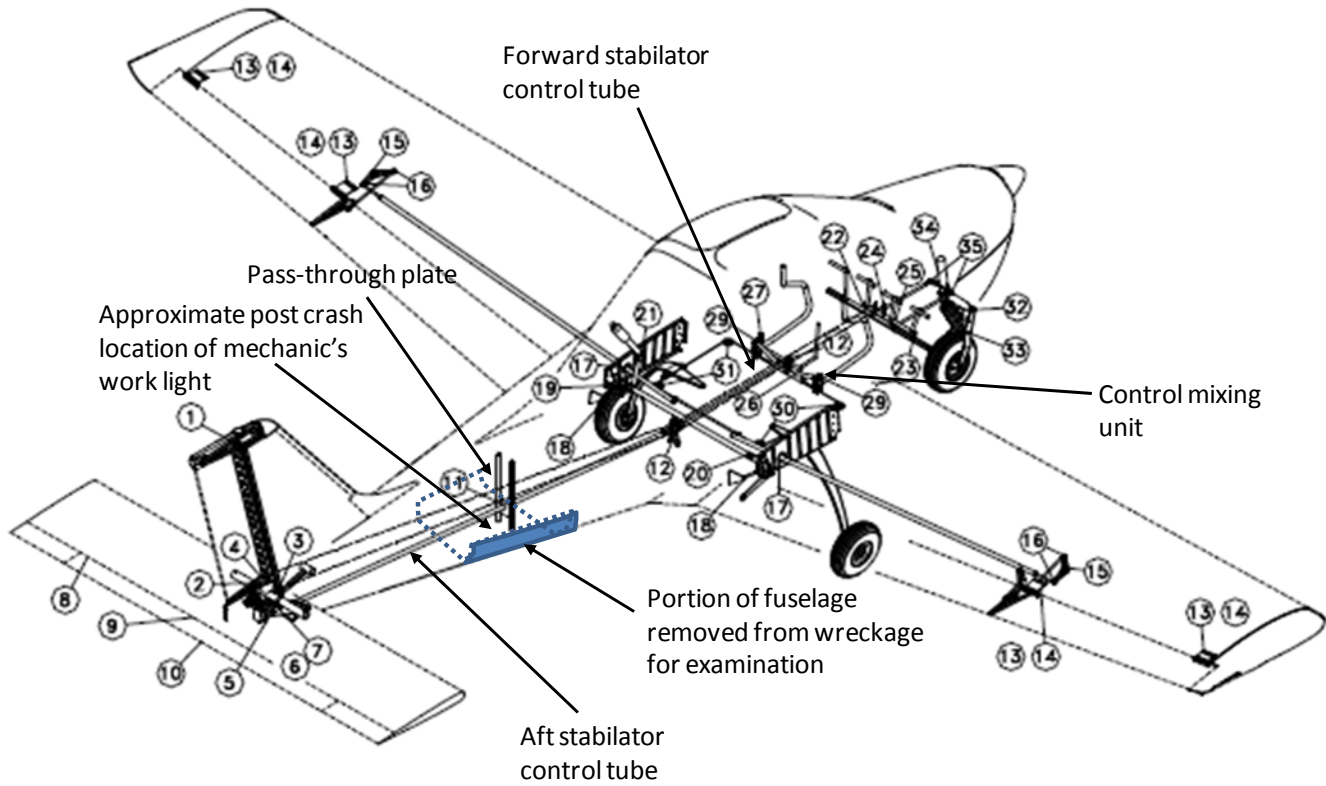
As indicated in Figure 1 and 3, a mechanic's work light was discovered within the tail section of the fuselage after the accident. Figure 7 shows views of the primary surfaces of the work light. There are no manufacturer marks on the exterior surfaces of the work light or under the rubber handle grip, which readily slides off the handle. The initials *WBS* are written on the side of the work light as shown in Figure 7a and on the back side of the handle under the rubber handle grip. A wear scar was observed on the side of the light as indicated in Figure 7d.

Figure 3 Image of the aircraft showing the relative arrangement of components identified in Figure 2.
